MUNICIPALITY OF  
**BRIGHTON**

**Municipality of Brighton Storm Pond Annual  
Report 2023**

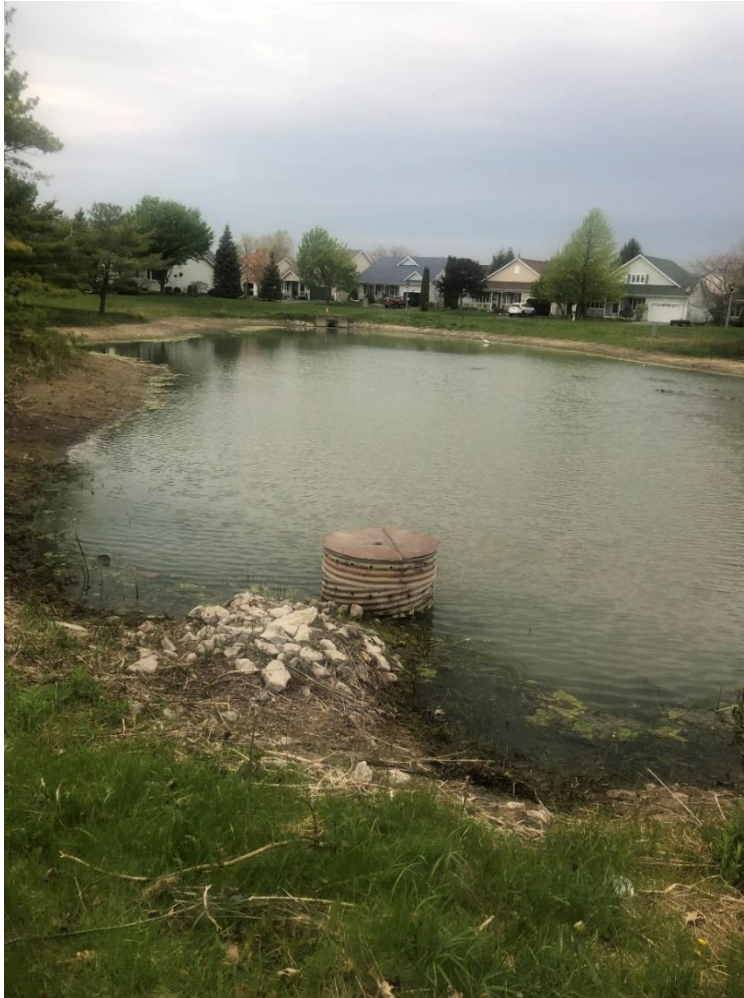
The wetland consists of one inlet discharging stormwater into the forebay located in the north portion of the pond. An inlet diversion weir in the manhole just upstream of the pond directs low flows to the wetland while allowing large rain events to by-pass the wetland and drain directly to the sewer on Mills Rd. There is one outlet structure at the south end of the pond, made from a perforated steel riser, connected to a 6" cast iron pipe that ultimately discharges stormwater into Presqu'île Bay Marsh (Lake Ontario), in the marina located east of the Harbour St. and Marina Dr. intersection. This outlet structure is surrounded by rip-rap stone, lined with filter cloth, that is designed to keep vegetation, snails, debris, etc. from plugging up the perforated drain holes.

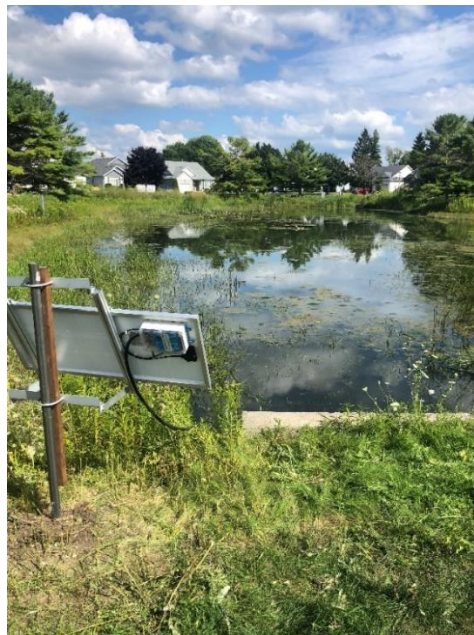
The excessive floating algae is a result of warm temperatures in the summer months, stagnant water due to low flow/draining, abundance of vegetation around the pond, build-up of sediment/vegetation in the forebay, or any combination of these factors. This problem can be minimized by keeping the drain holes in the outlet clear, however, this often is not enough.

So, to mitigate some of the prevailing and limiting issue, the Municipality of Brighton contracted “Blue Frog Water Gardens Pond Services” to install an air diffused, bubbler aerator system in the forebay of the pond. This is used to keep the water moving in the pond, thus minimizing the ability of algae to form due to stagnant water. It runs on solar power, making it energy efficient. It was successful to a degree, however, it likely is not powerful/large enough to protect the entire pond from algae. To account for this, staff also used “Blue Frog Water Gardens Pond Services” to cleanout the pond every month, by removing excessive vegetation, clean out the forebay sediment, add pond conditioners to aid with algae growth, etc. This helped the pond a lot, so these services will likely be utilized again this year.

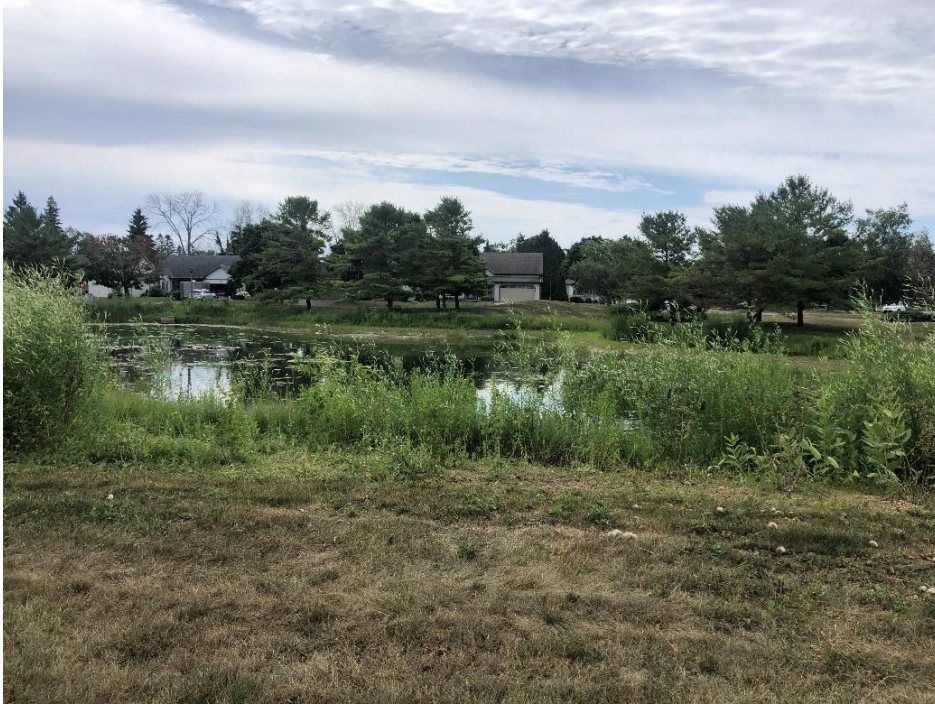
The last main issue, the abundance of noxious thistle weeds, is a result of seeds from these plants being airborne and spreading around the pond. Initially, staff investigated spraying

these weeds with a pesticide, however, it was determined that this was not a viable option due to proximity of good vegetation, and the wildlife that frequents this pond. Therefore, we ended up hand-pulling the weeds from the inlet and outlet pond edges, which significantly improved the appearance of the pond.

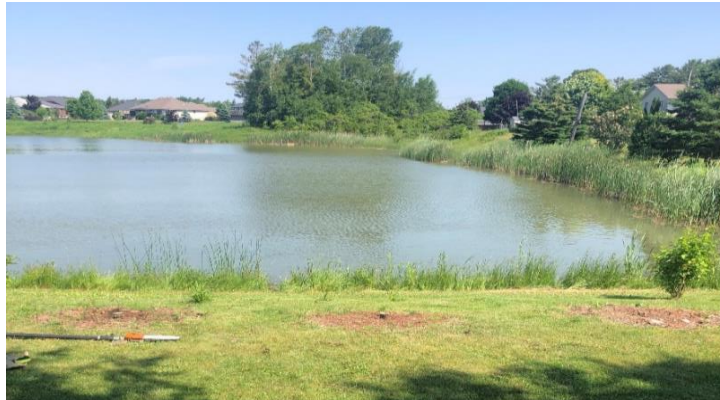
- Dead trees;
- Excessive noxious thistles along the west shoreline;
- Abundance of ragweed along the north shoreline and the northwest corner of the pond that block resident's view of the pond; and,
- Access road/trail to the pond from Beacon Dr.

The dead trees, a total of 4 small trees, were easily removed with a chainsaw to provide a more aesthetically pleasing view for residents.

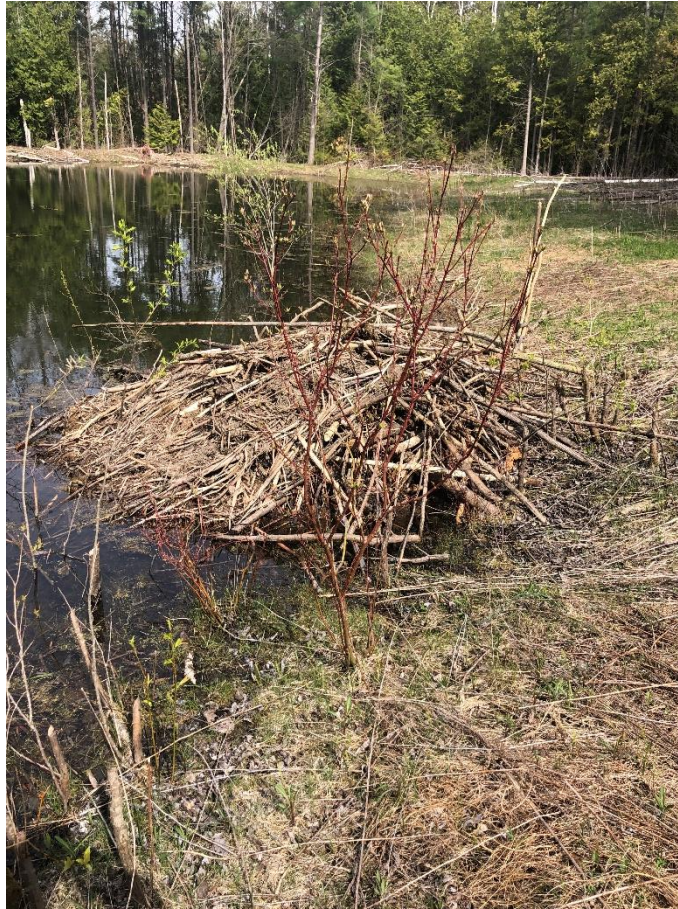
This pond generally performs very well and is quite visually appealing, however, there is one major factor that complicates matters a bit – beavers. They have a lodge located on the east shore of the pond, and the main issue they cause is that they consistently dam up the outlet with sticks, branches, mud, etc., which in turn does not allow the pond to properly drain, resulting in an elevated water level. Another minor issue they create is the amount of fallen trees that they have cut down around the pond.

To deal with this issue in a humane manner, the municipality has contracted a wildlife trapper to catch and relocate the beavers. The trapper was successful in trapping and relocating eight (8) beavers in 2023. Unfortunately, with the beavers able to reproduce quickly, the trapper was not able to get ahead of them, leaving more beavers that continue to make this pond their home.

The outlet was manually cleared multiple times in 2023 that allowed the water level to come down, although this was short-lived as the beavers are extremely quick at plugging up the outlet drain after it is cleared. This process often takes them less than a day to do, which does not leave sufficient time for the pond drain down completely.

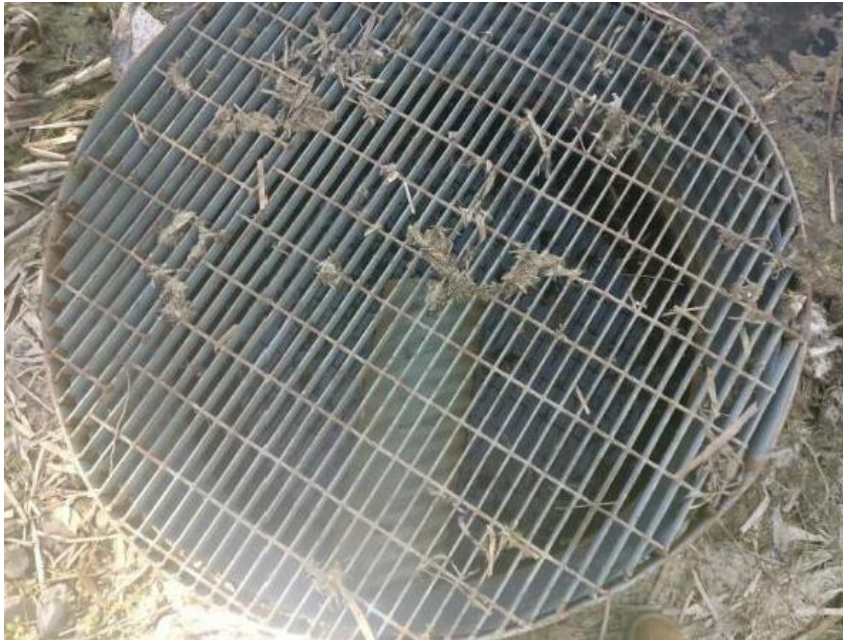
Another minor concern that was noted during the inspection was the overgrowth of vegetation and the presence of small tree branches/sticks in the outlet area. This was not hindering the pond's ability to drain out properly, however, it was also not the most visually appealing, and could potentially cause draining issues in the future. To alleviate this, the vegetation and branches were removed by hand during inspection to prevent any further issues going forward.

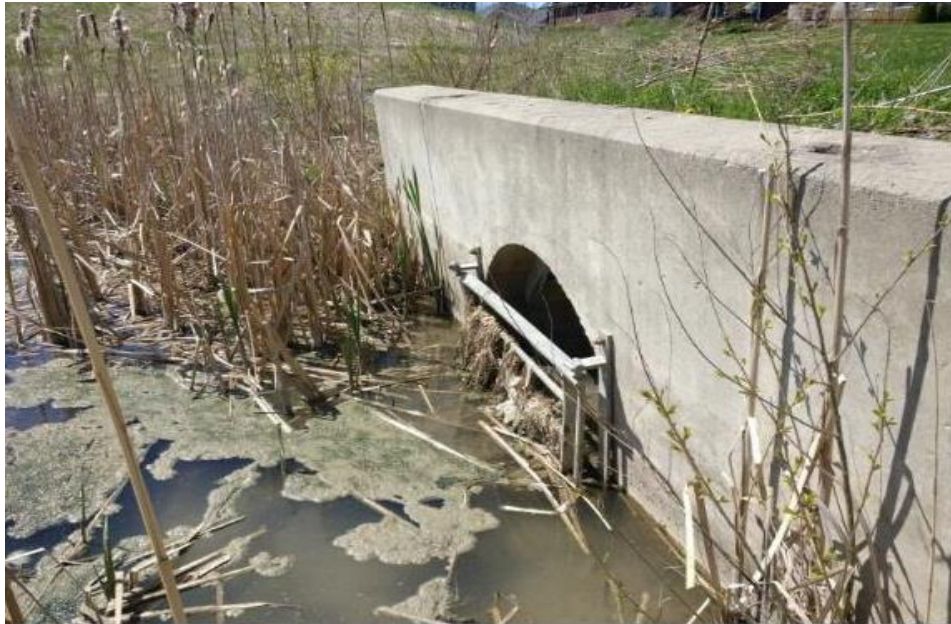
Another small aesthetic concern that was only noticed once during an inspection was the presence of some floating algae on the water surface. This was not a concern as this is normal with storm ponds in the warmer months, and the amount was very minimal.

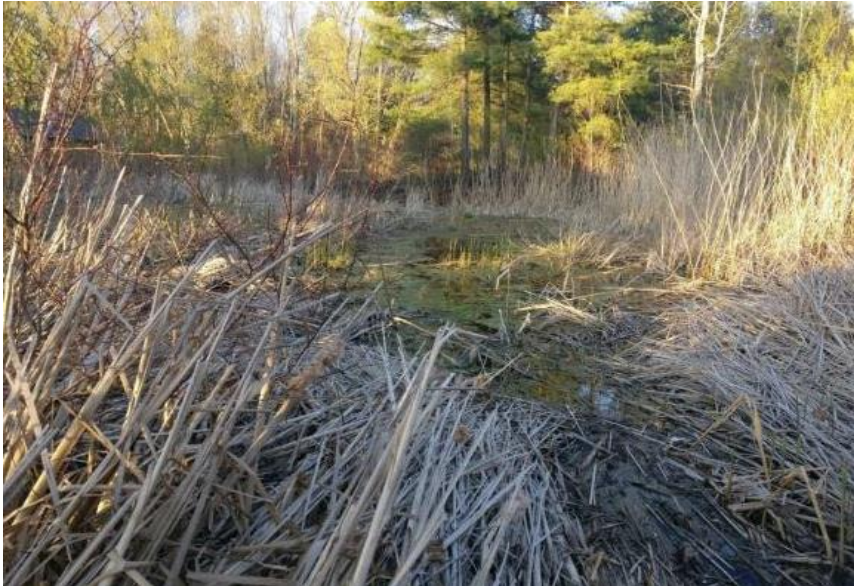
The Roos Storm Pond received no complaints or concerns from residents in 2023, however, there was some concern during inspection regarding the amount of vegetation in and around the pond. The excessive vegetation was prominent around the perimeter of the pond, with some present in the inlet and outlet areas as well. This contributed to an elevated water level at times during the year, especially after rain events. In the summer months, it also made it difficult to manoeuvre around the pond and reach certain areas. It should be noted that during inspection, the water was flowing freely without issue.

To combat this, more attention will need to be paid on removing the excessive vegetation prior to it becoming an issue that affects the water level in the pond. In any event, it will need to be monitored more often and cut back whenever necessary, by hand or by tool.
