# Hydrogeological Assessment - 214 Ontario Street, Brighton, Ontario (Rev.1)

Prepared for:  
Bicorp Design Group Ltd.

Cambium Reference: 13654-001

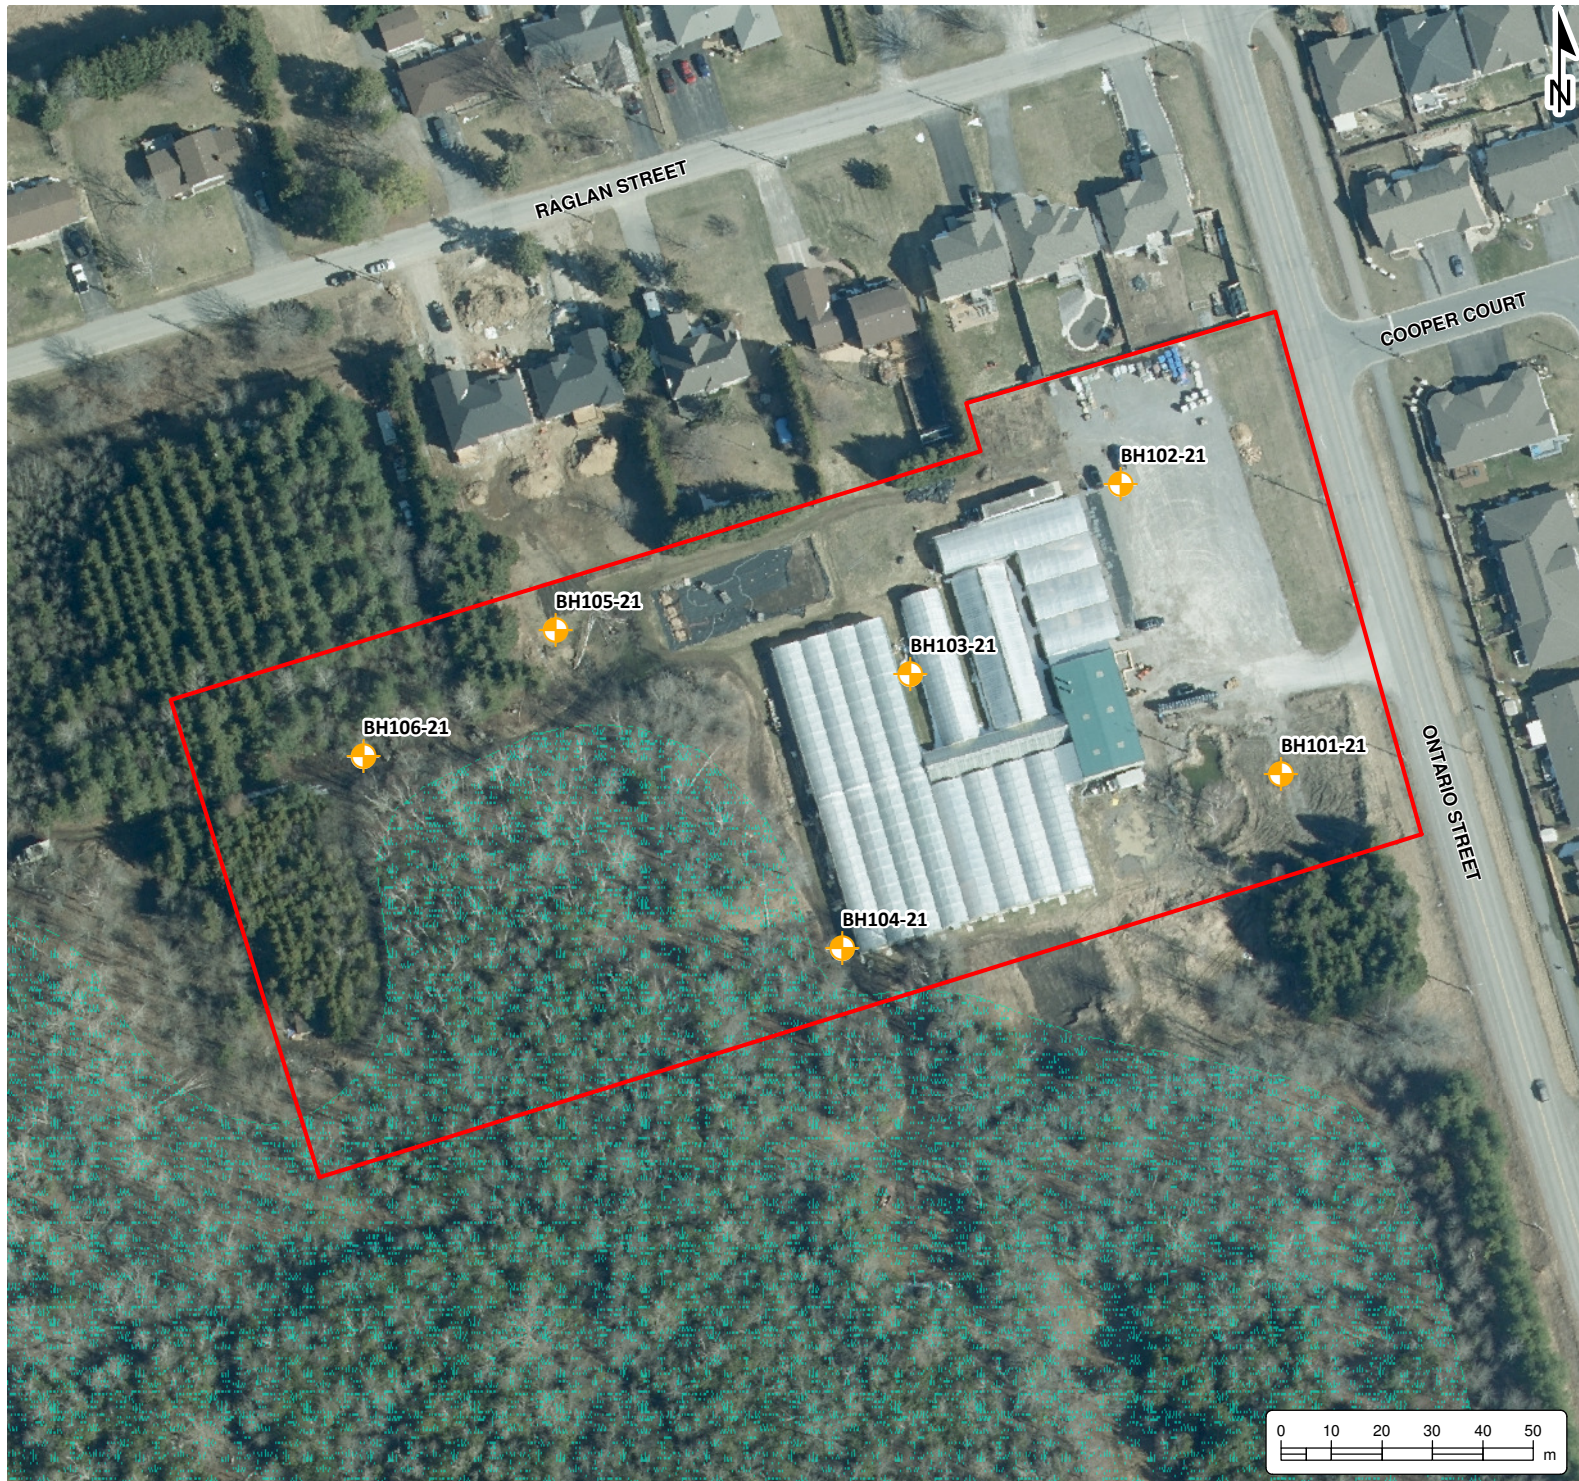
A drilling program was completed at the Site which included six (6) boreholes advanced across the Site from August 30 to 31, 2021. Boreholes were advanced to depths ranging from 6.1 to 6.7 mbgs. The locations of the boreholes relative to the existing site conditions are provided on Figure 1. Records of the individual boreholes are provided in Appendix B.

The Site is approximately 2.5 hectares (ha) in size and is currently developed with a greenhouse complex and associated gravel parking lot and driveways. The existing development occupies the eastern portion of Site. Undeveloped, forested land occupies the western portion of the Site. In addition, unevaluated wetlands have been mapped historically within the southwestern portion of the property. However, information provided by the Lower Trent Conservation Authority (LTCA) indicates that there are no wetlands present on-site, as per field verification. See Appendix A. Land use at the Site is designated as Agricultural Zone (A-2). The Site is bordered by Urban Residential Zone One (R1) to the north, undesignated lands to the west and south, and Ontario Street to the east. The proposed residential development includes a total of 87 townhouse units and associated infrastructure including, but not limited to, roads, sidewalks, and park space. Some of the buildings will be constructed with one (1) underground level (basement). The proposed development will be provided water and wastewater servicing from the Town of Brighton. Detailed design information was not available at the time this report was prepared. A Site plan is outlined on Figure 1; a proposed development plan is included in Appendix A.

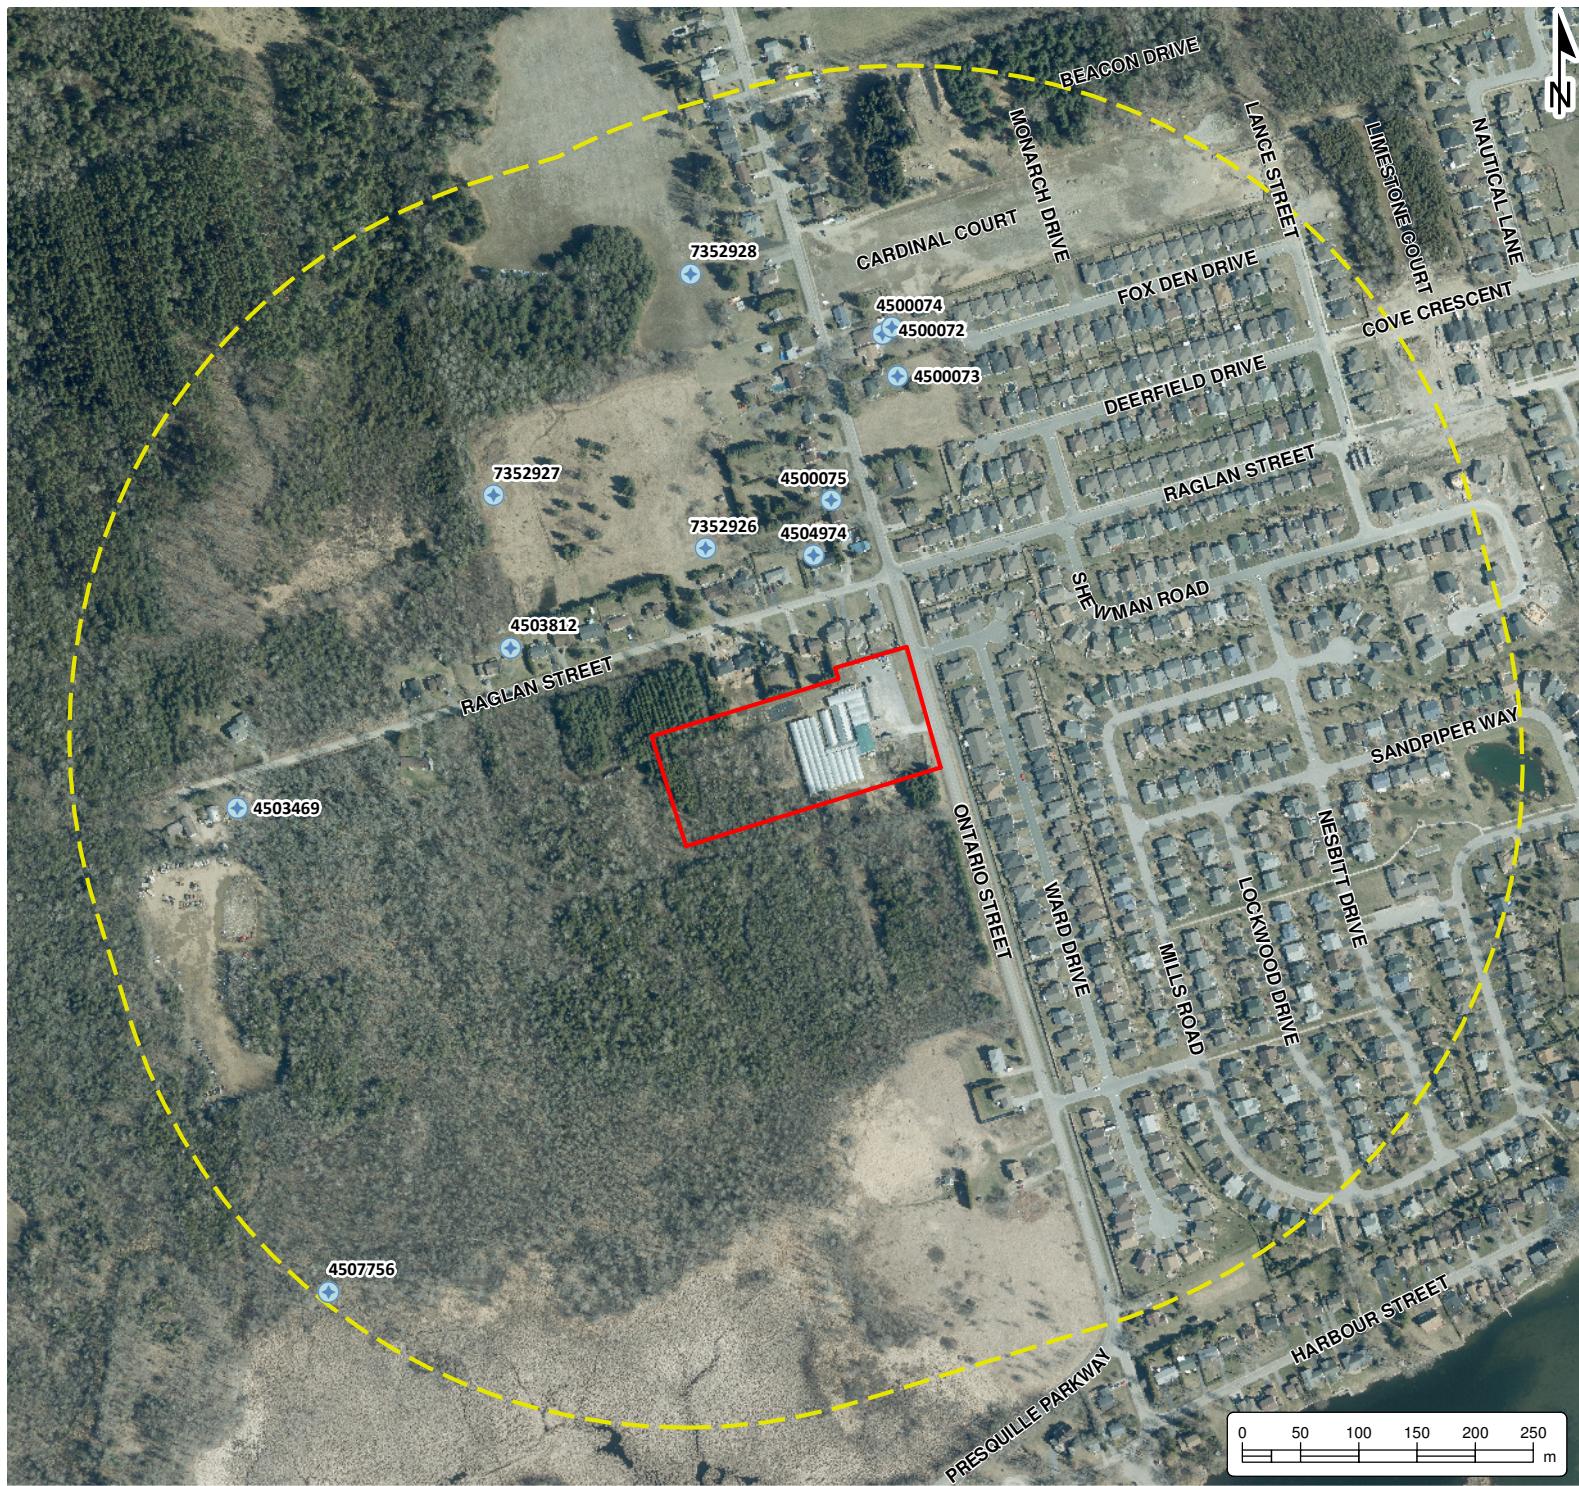
**WATER WELL RECORDS  
 WITHIN 500m OF SITE**

As per the MECP records, the soil profile generally consisted of sand overlying clay sediments. Six (6) of the drilled wells were advanced into bedrock composed of limestone; the bedrock contact was found between 0.6 and 8.4 metres below ground surface (mbgs), average of 2.2 mbgs. Bedrock continued until well termination. Water bearing sediments were identified within well records with thicker overburden profiles at approximately 9 mbgs. Water bearing strata were also identified in the six (6) drilled bedrock well records; it was inferred that two aquifers were present within the bedrock: a shallow aquifer within 6 m of the bedrock contact, and a deeper aquifer encountered between 11.9 and 14.6 m below the bedrock contact.

The static water level of the drilled wells ranged between 0.6 to 4.9 mbgs, with an average static water level of 1.9 mbgs. The recommended flow rate ranged from 3 gallon per minute (gpm, assumed to be US gallons per minute) to 40 gpm, averaging 13 gpm. Further information summarized from the water well records are listed below in Table 2.

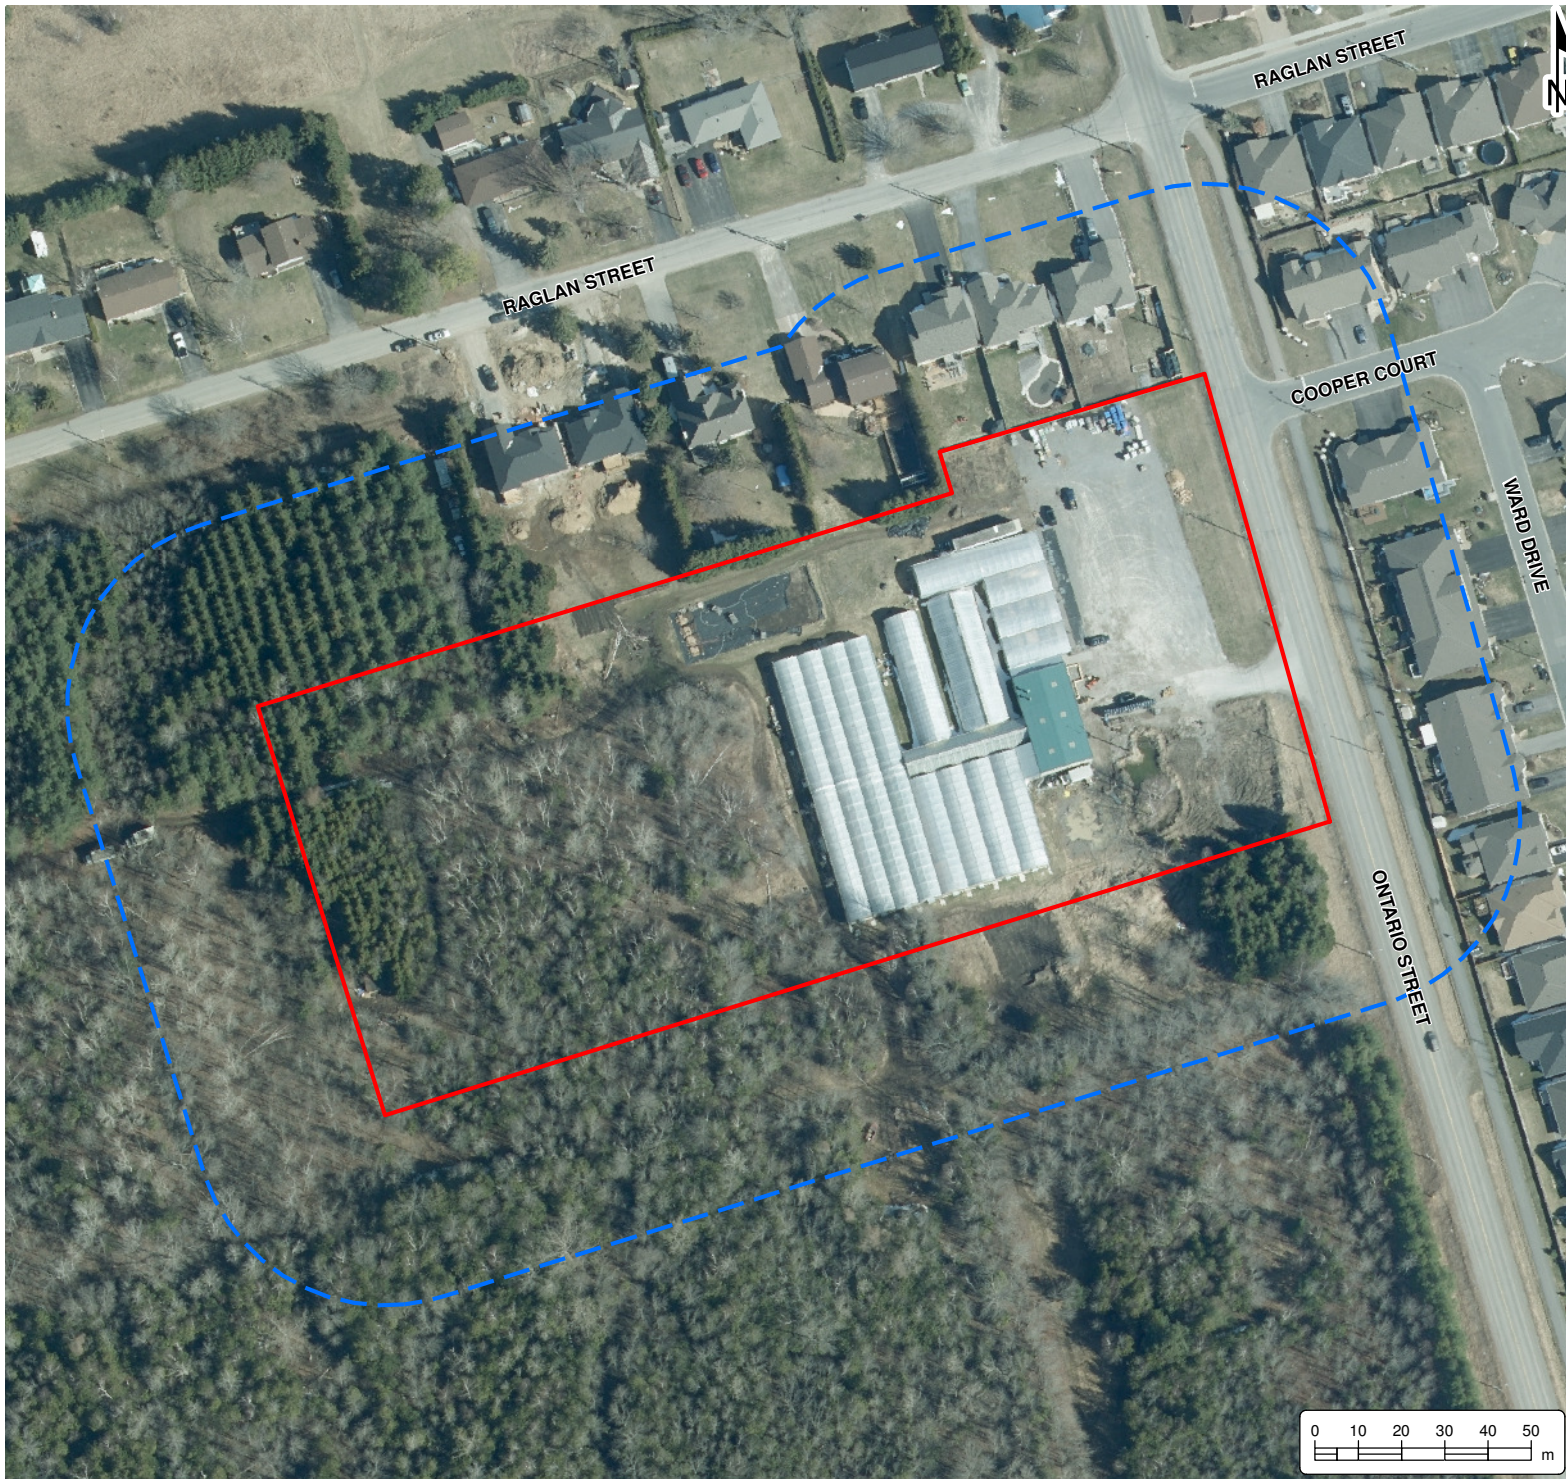
It was assumed the foundations of the individual townhouse units will be built together at the same time, within the footprint of a common structure. The water level during construction dewatering was assumed to be 1.0 mbgs based off the shallowest groundwater reading measured on September 14, 2021. To estimate daily dewatering rates it was assumed that the water level will be lowered 0.5 m below the floor of the excavation (to a depth of 3.5 mbgs); therefore, groundwater levels must be lowered by 2.5 m.

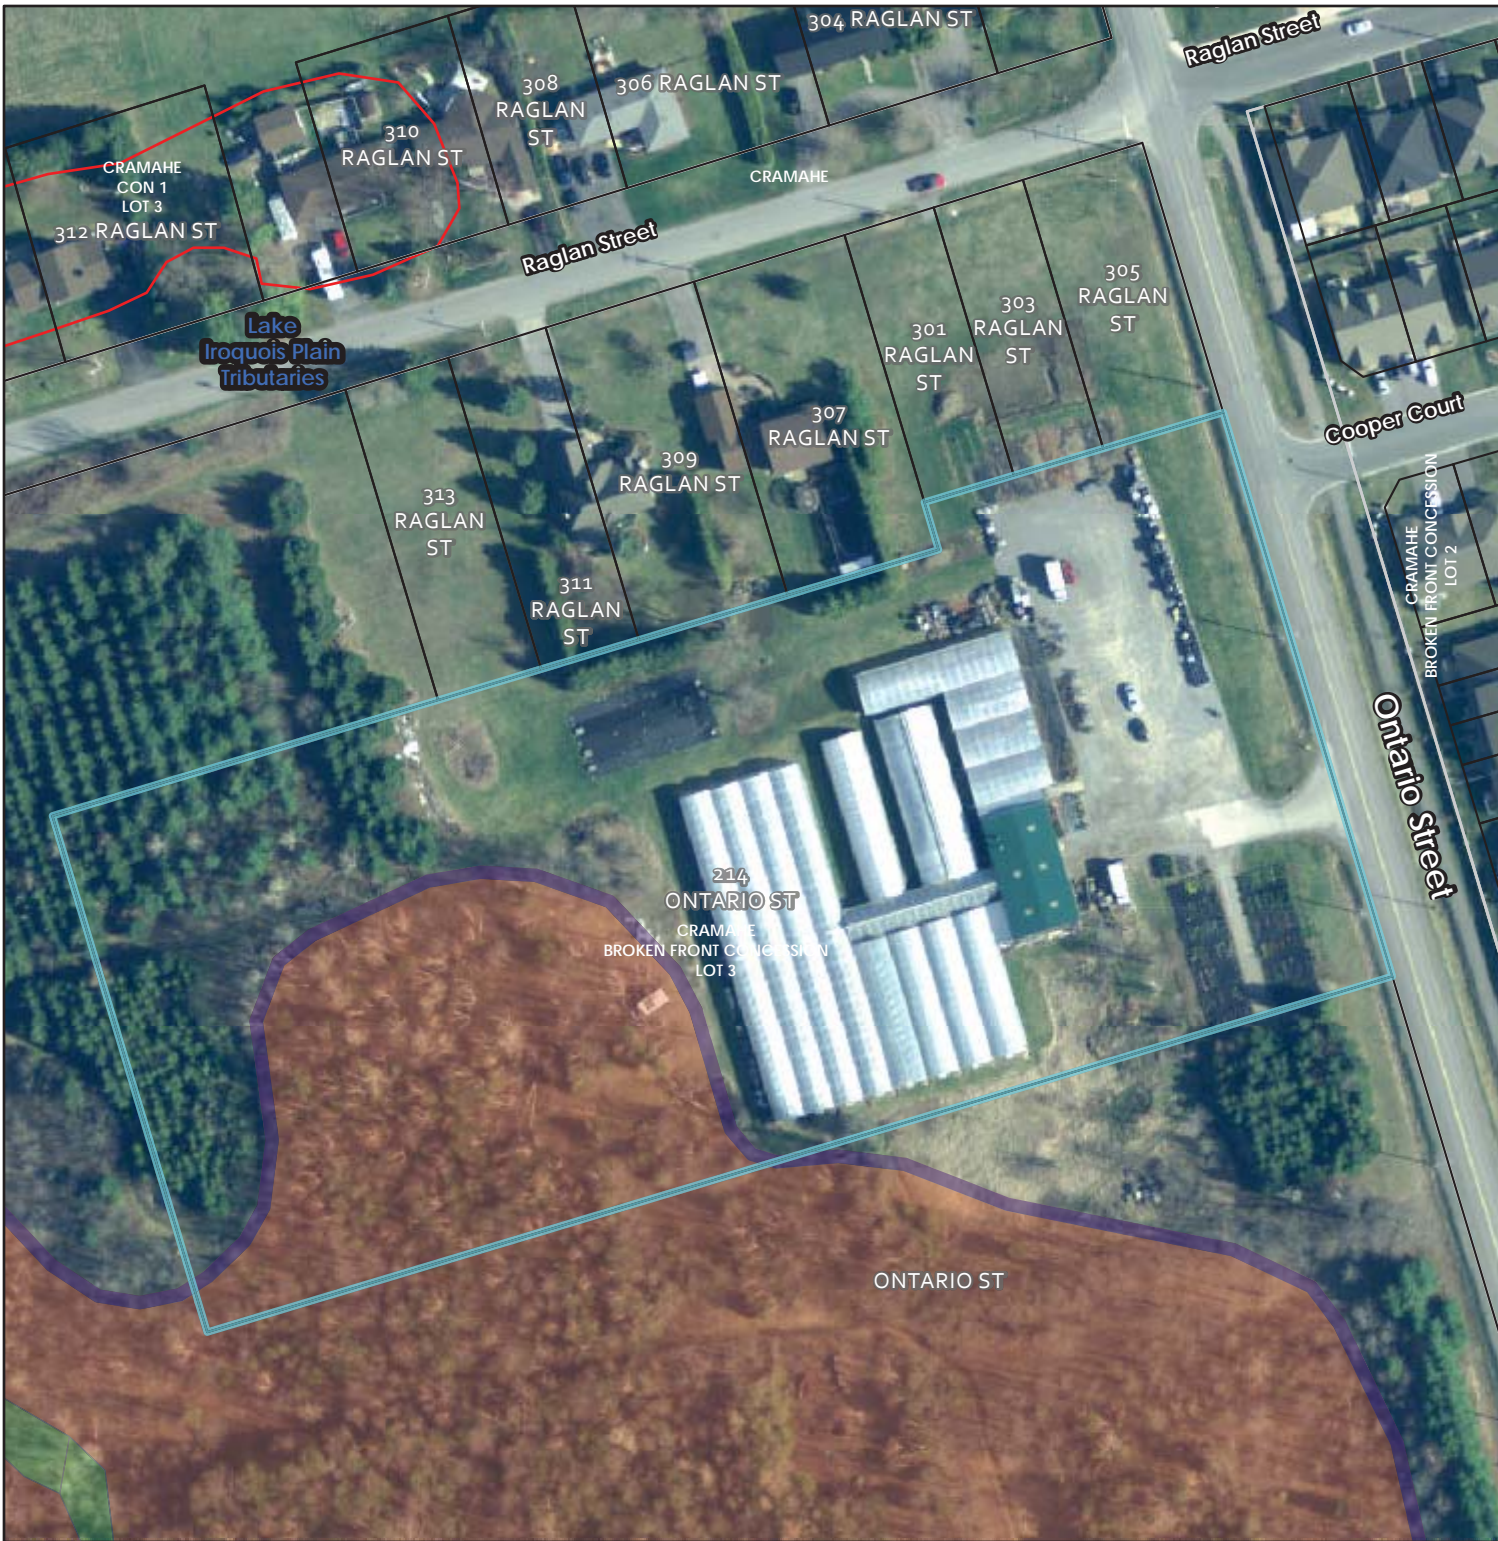
**A1-H5**  
2020-20

PROJECT: BRIGHTON FREEHOLD TOWNHOUSE DEVELOPMENT			
214 ONTARIO STREET, BURLINGTON, ONTARIO			
THIS SITE PLAN - DESIGN H5			
DESIGNED BY: R.A.	DRAWN BY: D.B.	APPROVED BY: D.B.	
DATE: 12/20	SCALE:	ISSUE DATE: JULY 2020	PROJECT CODE: 08-19-2021

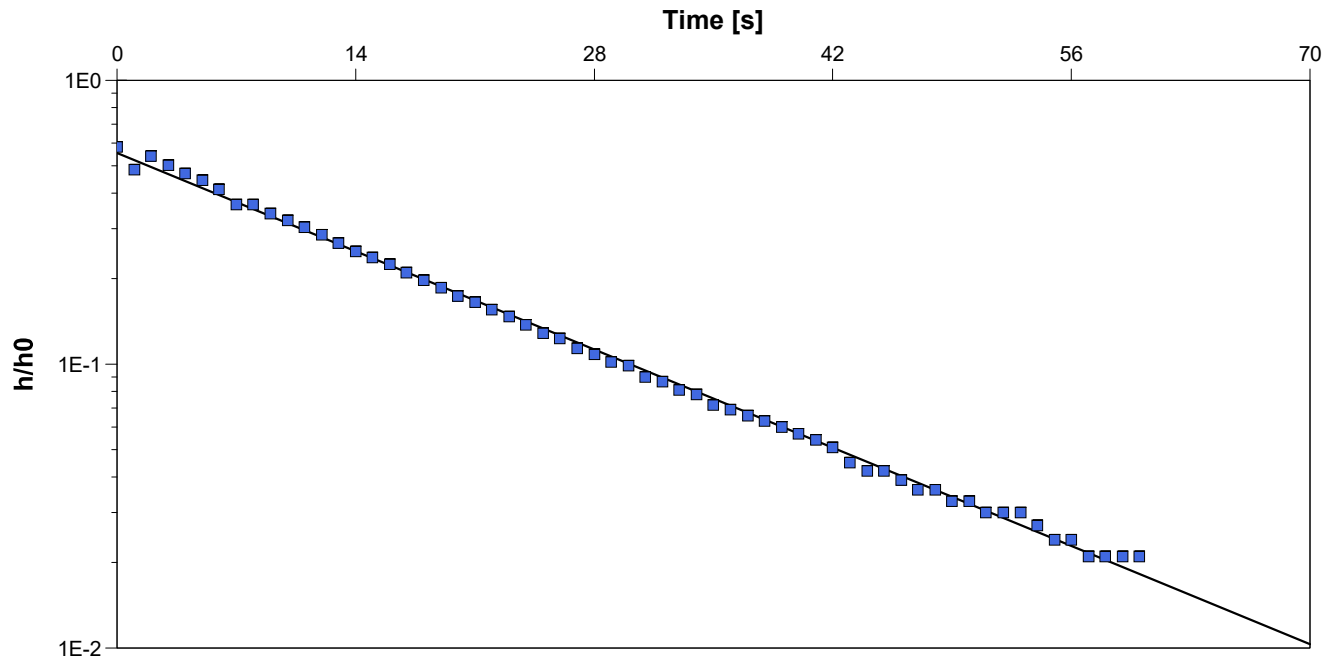
Location: Brighton, Ontario	Slug Test: BH102-21 Test 1	Test Well: BH102-21
Test Conducted by: J. Munro		Test Date: 9/16/2021
Analysis Performed by: N. Heikoop	BH102-21 Test 1	Analysis Date: 9/29/2021
Aquifer Thickness: 4.23 m

Calculation using Hvorslev		
Observation Well	Hydraulic Conductivity [m/s]	
BH102-21	$3.06 \times 10^{-5}$

On September 14, 2021, Cambium staff visited the Site to complete Single Well Hydraulic Tests (SWHTs) on the three (3) monitoring wells. The SWHTs were completed by inducing an instantaneous change in groundwater head in the well and monitoring water level recovery. Water level recovery was monitored using an automated water level logging device and validated with manual measurements. The hydraulic conductivity of water bearing units screened in each well were estimated using AquiferTest Pro™ software, the results of which are attached in Appendix D and are discussed further in Section 4.1.

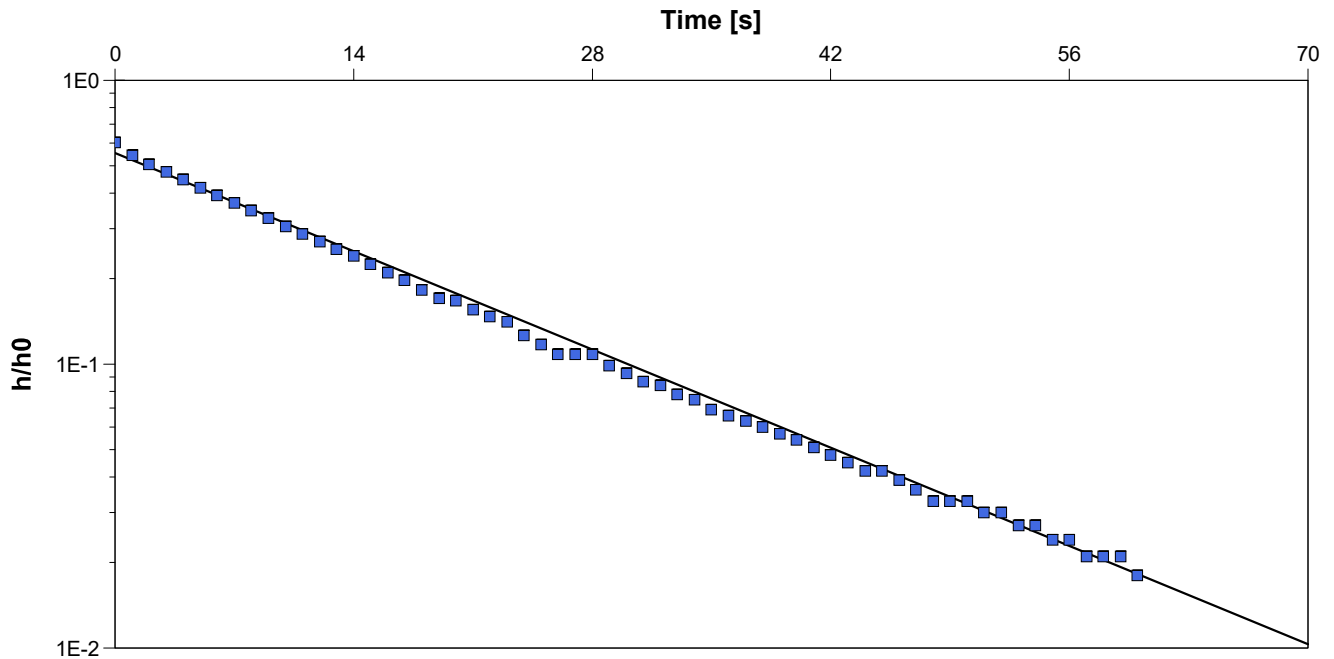
Location: Brighton, Ontario	Slug Test: BH102-21 Test 2	Test Well: BH102-21
Test Conducted by: J. Munro		Test Date: 9/16/2021
Analysis Performed by: N. Heikoop	BH102-21 Test 2	Analysis Date: 9/29/2021
Aquifer Thickness: 4.23 m

Calculation using Hvorslev		
Observation Well	Hydraulic Conductivity [m/s]	
BH102-21	$3.06 \times 10^{-5}$

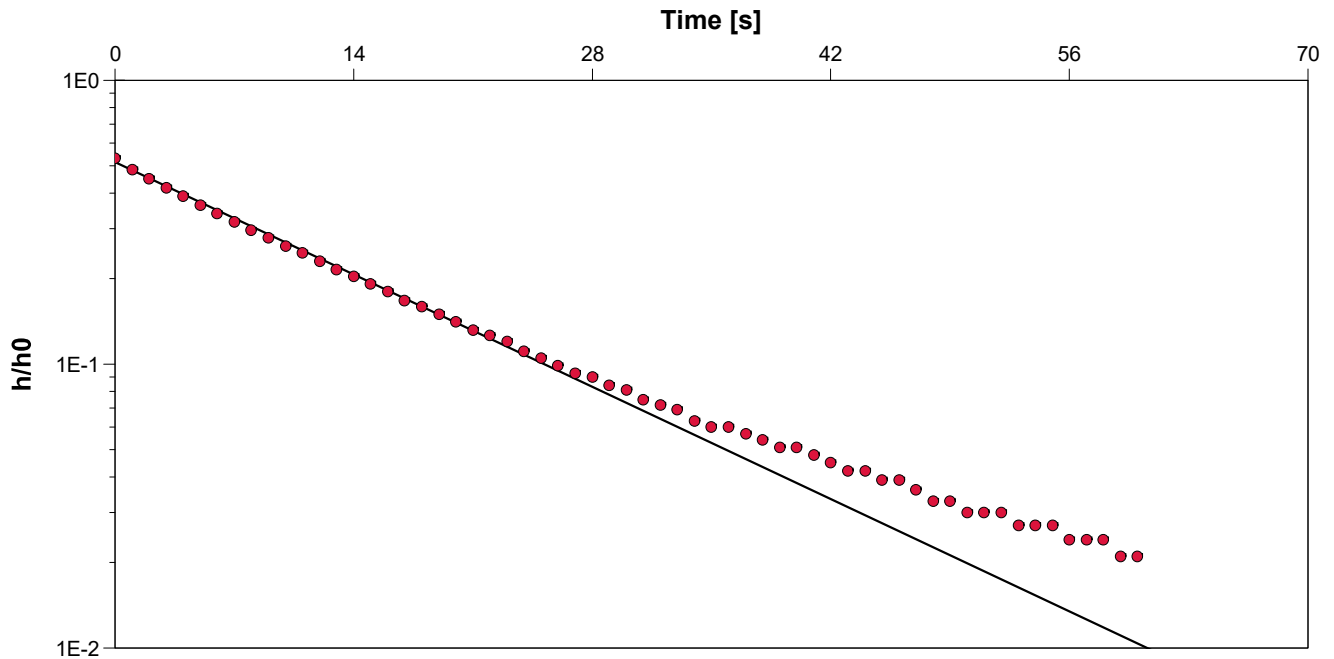
Location: Brighton, Ontario	Slug Test: BH104-21 Test 1	Test Well: BH104-21
Test Conducted by: J. Munro		Test Date: 9/16/2021
Analysis Performed by: N. Heikoop	BH104-21 Test 1	Analysis Date: 9/29/2021
Aquifer Thickness: 4.79 m

Calculation using Hvorslev		
Observation Well	Hydraulic Conductivity [m/s]	
BH104-21	$3.50 \times 10^{-5}$

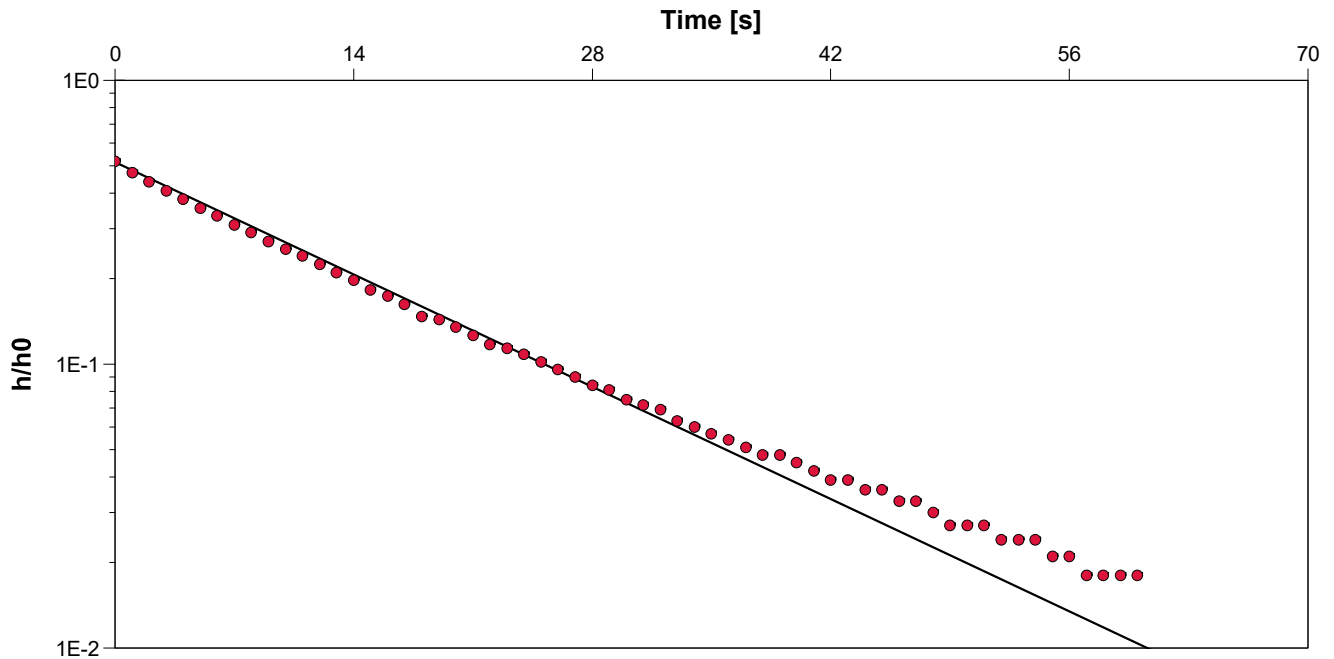
Location: Brighton, Ontario	Slug Test: BH104-21 Test 2	Test Well: BH104-21
Test Conducted by: J. Munro		Test Date: 9/16/2021
Analysis Performed by: N. Heikoop	BH104-21 Test 2	Analysis Date: 9/29/2021
Aquifer Thickness: 4.79 m

Calculation using Hvorslev		
Observation Well	Hydraulic Conductivity [m/s]	
BH104-21	$3.50 \times 10^{-5}$

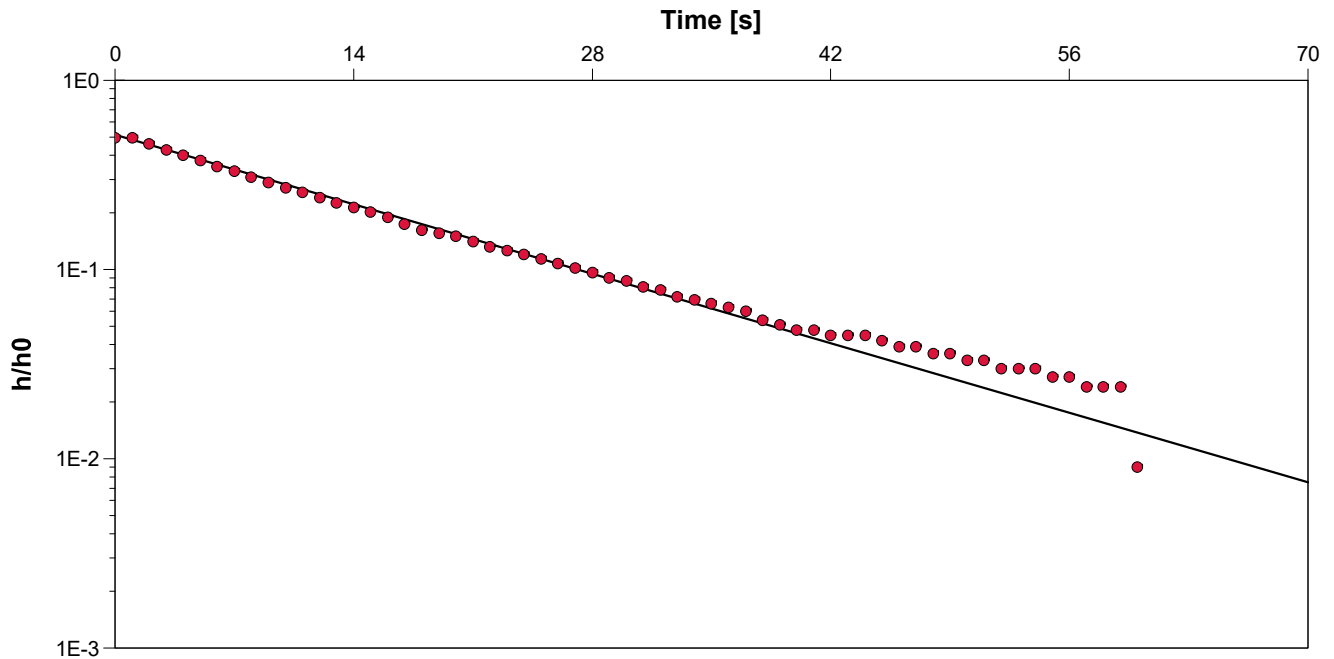
Location: Brighton, Ontario	Slug Test: BH104-21 Test 3	Test Well: BH104-21
Test Conducted by: J. Munro		Test Date: 9/16/2021
Analysis Performed by: N. Heikoop	BH104-21 Test 3	Analysis Date: 9/29/2021
Aquifer Thickness: 4.79 m

Calculation using Hvorslev		
Observation Well	Hydraulic Conductivity [m/s]	
BH104-21	$3.25 \times 10^{-5}$

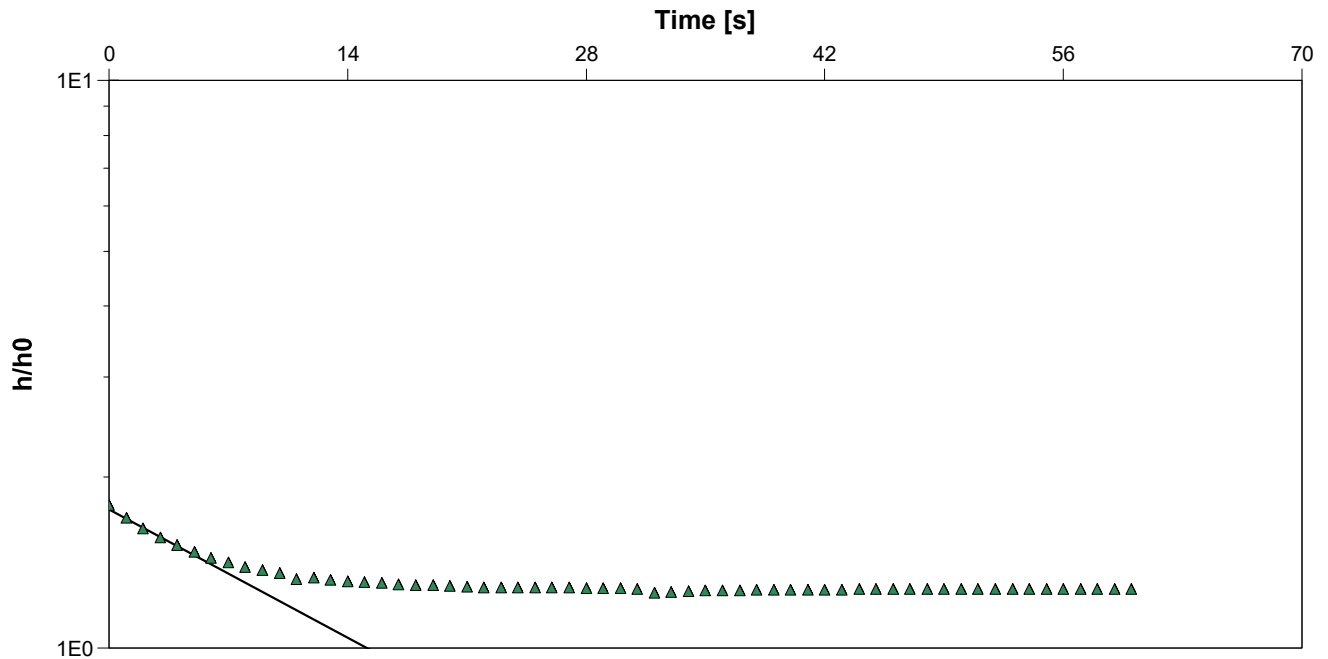
Location: Brighton, Ontario	Slug Test: BH106-21 Test 1	Test Well: BH106-21
Test Conducted by: J. Munro		Test Date: 9/16/2021
Analysis Performed by: N. Heikoop	BH106-21 Test 1	Analysis Date: 9/29/2021
Aquifer Thickness: 2.35 m

Calculation using Hvorslev		
Observation Well	Hydraulic Conductivity [m/s]	
BH106-21	$2.00 \times 10^{-5}$

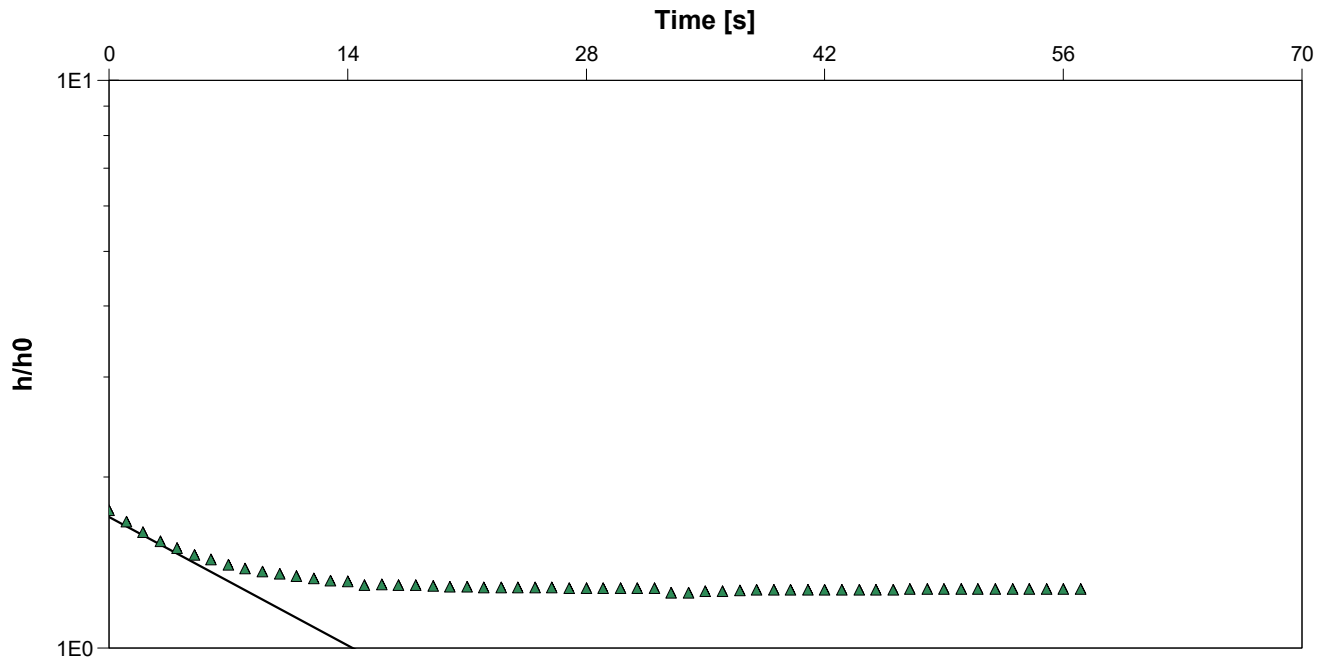
Location: Brighton, Ontario	Slug Test: BH106-21 Test 2	Test Well: BH106-21
Test Conducted by: J. Munro		Test Date: 9/16/2021
Analysis Performed by: N. Heikoop	BH106-21 Test 2	Analysis Date: 9/29/2021
Aquifer Thickness: 2.35 m

Calculation using Hvorslev		
Observation Well	Hydraulic Conductivity [m/s]	
BH106-21	$2.00 \times 10^{-5}$

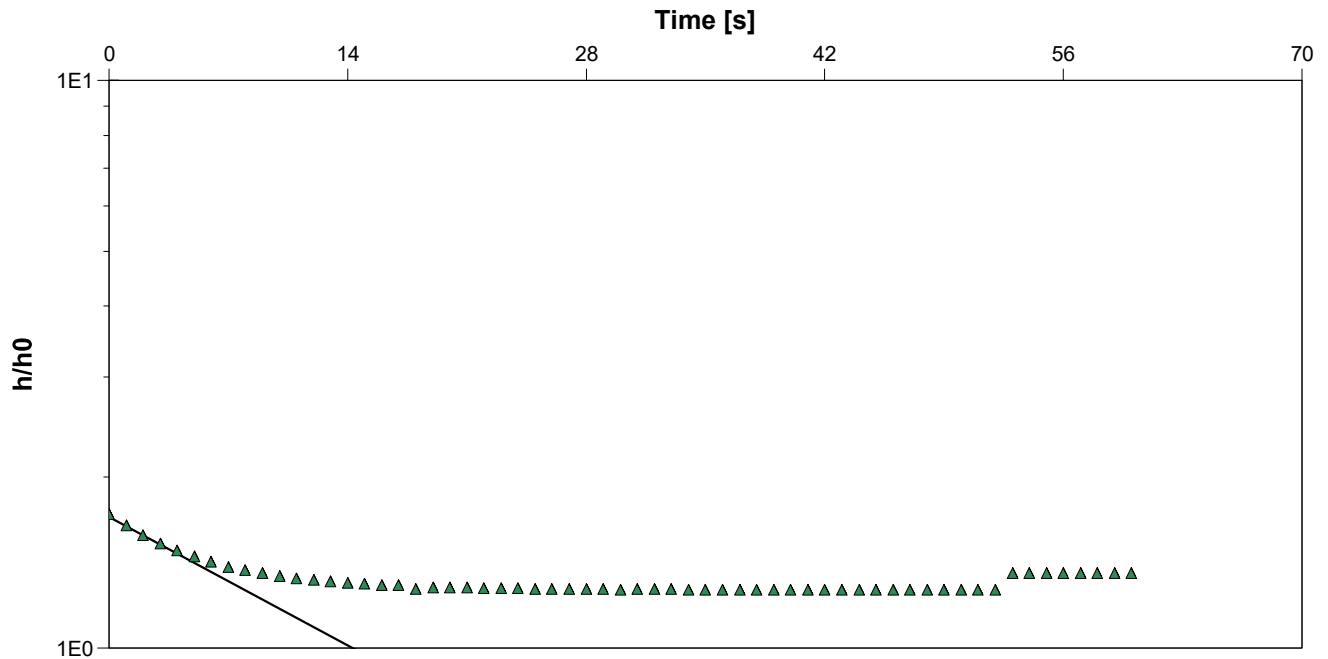
Location: Brighton, Ontario	Slug Test: BH106-21 Test 3	Test Well: BH106-21
Test Conducted by: J. Munro		Test Date: 9/16/2021
Analysis Performed by: N. Heikoop	BH106-21 Test 3	Analysis Date: 9/29/2021
Aquifer Thickness: 2.35 m

Calculation using Hvorslev		
Observation Well	Hydraulic Conductivity [m/s]	
BH106-21	$2.00 \times 10^{-5}$
