MUNICIPALITY OF  
**BRIGHTON**

**Municipality of Brighton Storm Pond Annual  
Report 2023**

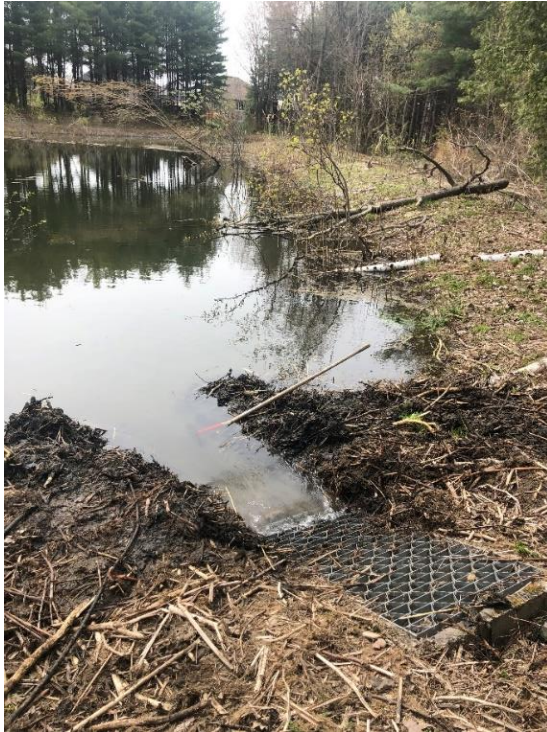
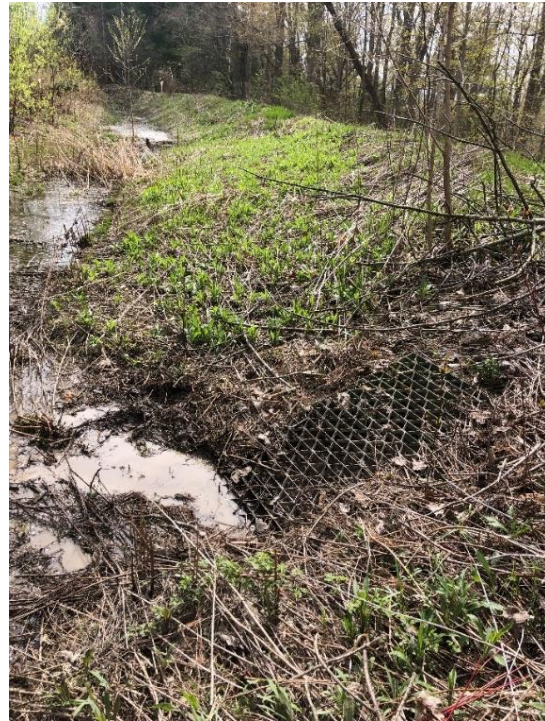
the pond in the form of a steel, grated drain set on an angle to allow water to fall into it and drain out. This connects to a manhole just downstream, which then leads the water towards Butler Creek. There is also an overflow by-pass located on the west shore that runs under the trail, designed to drain water out of the pond should the water level get too high.

The dry pond looks like a ditch, has one inlet on the west side and one outlet on the east side. The outlet consists of an angled, grated drain that directs the water down a hill (made up of riprap) that then falls into Butler Creek.

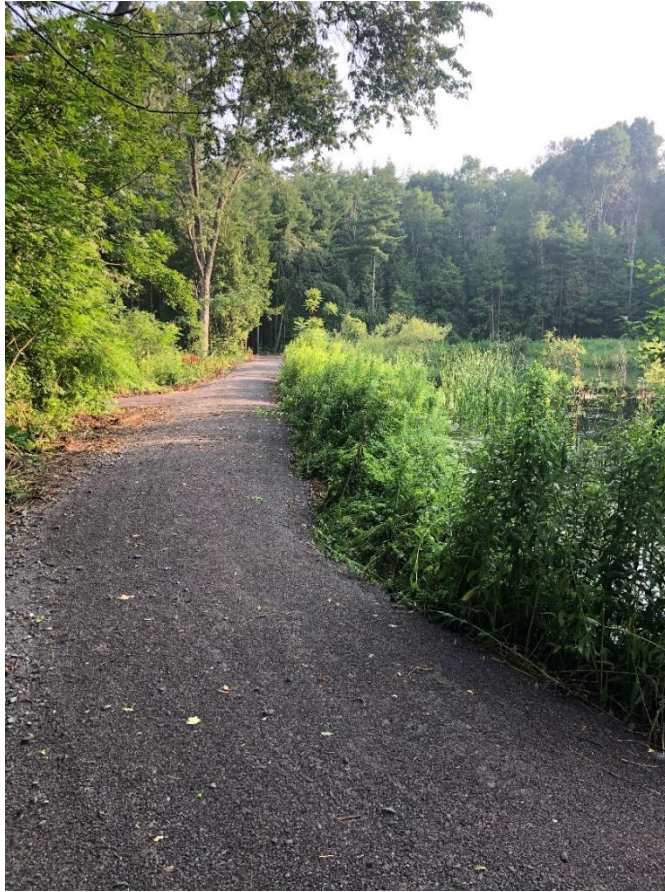
This pond generally performs very well and is quite visually appealing, however, there is one major factor that complicates matters a bit – beavers. They have a lodge located on the east shore of the pond, and the main issue they cause is that they consistently dam up the outlet with sticks, branches, mud, etc., which in turn does not allow the pond to properly drain, resulting in an elevated water level. Another minor issue they create is the amount of fallen trees that they have cut down around the pond.

To deal with this issue in a humane manner, the municipality has contracted a wildlife trapper to catch and relocate the beavers. The trapper was successful in trapping and relocating eight (8) beavers in 2023. Unfortunately, with the beavers able to reproduce quickly, the trapper was not able to get ahead of them, leaving more beavers that continue to make this pond their home.

The outlet was manually cleared multiple times in 2023 that allowed the water level to come down, although this was short-lived as the beavers are extremely quick at plugging up the outlet drain after it is cleared. This process often takes them less than a day to do, which does not leave sufficient time for the pond drain down completely.

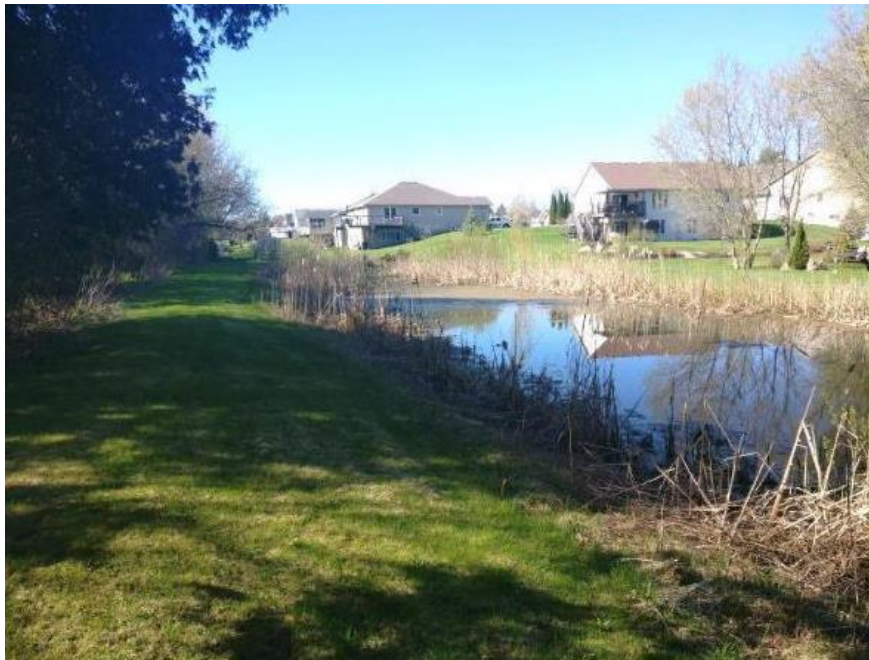
In 2023, there were no immediate concerns or complaints coming from residents, as the pond performed well as it has in the past. However, upon inspection, it was noted that the pond is likely due to be cleaned out in the next few years, based upon previous sediment data and projections as well as a visual inspection.

Another minor concern that was noted during the inspection was the overgrowth of vegetation and the presence of small tree branches/sticks in the outlet area. This was not hindering the pond's ability to drain out properly, however, it was also not the most visually appealing, and could potentially cause draining issues in the future. To alleviate this, the vegetation and branches were removed by hand during inspection to prevent any further issues going forward.

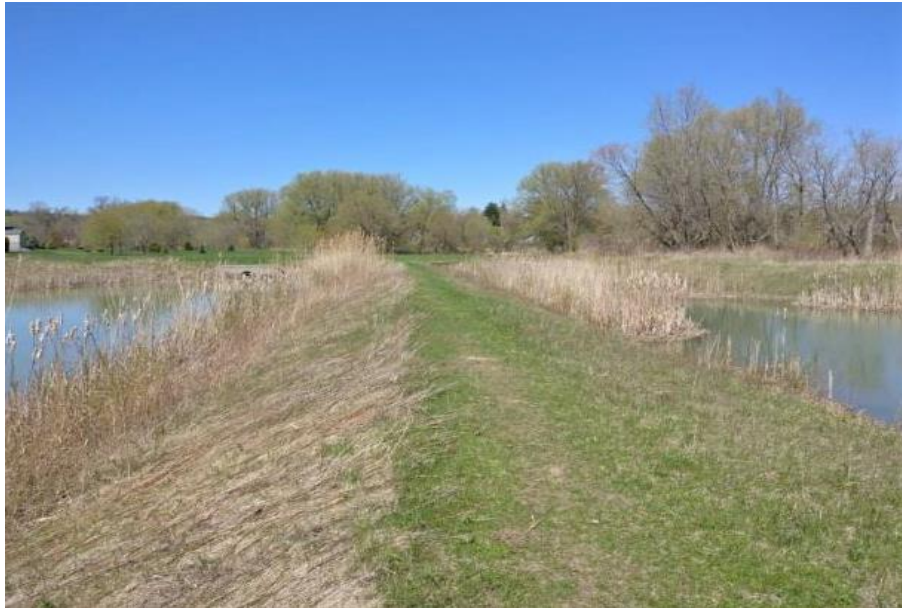
This pond performed very well in 2023 and no complaints were received, and inspections revealed no major issues at the pond. The only minor concerns that were noticed during inspections were the presence of the invasive species of plant called “phragmites”, which can take over an area and become the dominant plant. Luckily, the phragmites present at this pond was not overtaking other plants, so it only required to us to keep an eye out for it going forward.

Another small aesthetic concern that was only noticed once during an inspection was the presence of some floating algae on the water surface. This was not a concern as this is normal with storm ponds in the warmer months, and the amount was very minimal.

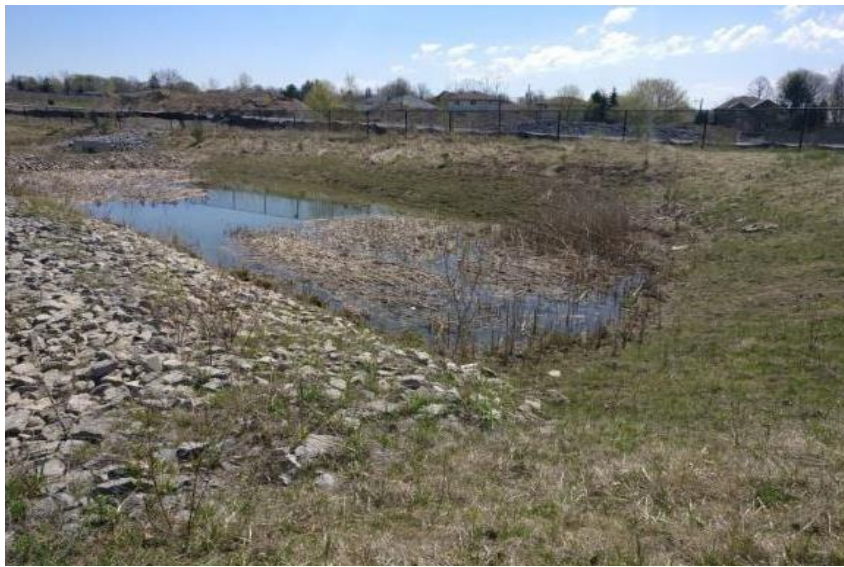
As this is a newer pond that was assumed by the municipality over the last few years, it predictably performed well in 2023. No complaints or concerns were brought forward by the residents, and any inspections that took place indicated the same. The one minor concern that was observed during inspections in 2023 was the amount of sediment present around the west inlet, off Pinnacle St. The sediment was very minor, but enough to be noted. It did not impede the flow the water coming into the pond either. Moving forward, this is an issue that will continue to be monitored and addressed as need be.

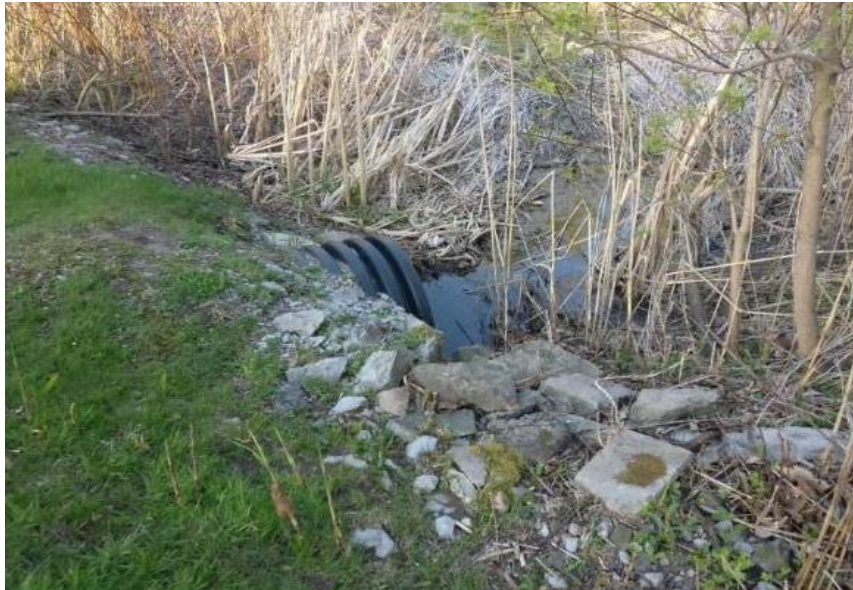
The Roos Storm Pond received no complaints or concerns from residents in 2023, however, there was some concern during inspection regarding the amount of vegetation in and around the pond. The excessive vegetation was prominent around the perimeter of the pond, with some present in the inlet and outlet areas as well. This contributed to an elevated water level at times during the year, especially after rain events. In the summer months, it also made it difficult to manoeuvre around the pond and reach certain areas. It should be noted that during inspection, the water was flowing freely without issue.

To combat this, more attention will need to be paid on removing the excessive vegetation prior to it becoming an issue that affects the water level in the pond. In any event, it will need to be monitored more often and cut back whenever necessary, by hand or by tool.
